Issue #57 September 2024

CHANGES IN THE MARTHA OPEN PIT

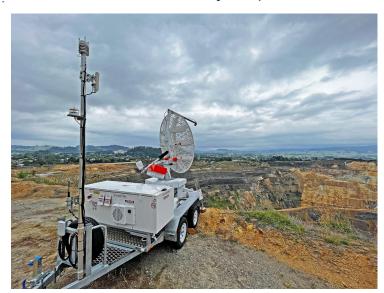
The Martha Open Pit walls are monitored using a combination of systems and technologies and have been for many years. 3D Real Aperture Radar (RAR) technology continuously monitors the southern wall, completing approximately 150 scans every 24 hours, with automated alerts in place should any results fall outside expected tolerances.

The Radar used to constantly monitor the Martha Open Pit.
